NASA TN D-4964

DEVELOPMENT OF IMPROVED THROAT INSERTS FOR ABLATIVE ROCKET ENGINES

by Jerry M. Winter and Donald A. Peterson

*Lewis Research Center
Cleveland, Ohio*

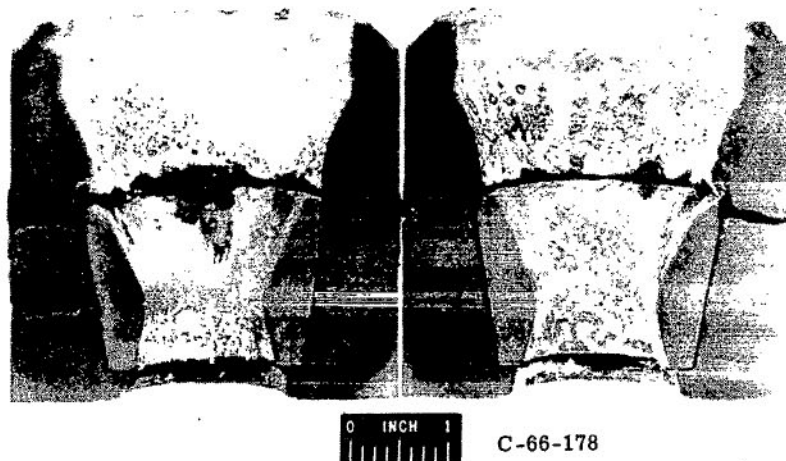
(35) Insert 35; injector 2

Material		Form	Manufacturer	Configuration (a)	Additional layers
Insert		HfC - SiC plus graphite (JT0992)		Sintered	National Carbon	A	None
Envelope		Silica phenolic (MX 2641)		90° centerline	Fiberite	4-in. (10.15-cm) o.d.	None
Run	Chamber pressure, P_c		Oxidant-fuel ratio, O/F	Run time, sec	Total change in effective throat radius, ΔR		Remarks
	psia	kN/m ²			in.	cm	
300	96.7	666	2.01	258.7	0.008	0.0203	Shutdown due to burn-through of ablative envelope

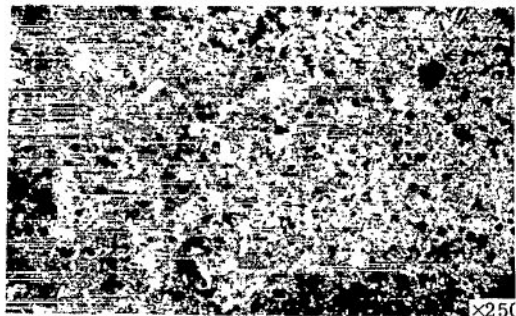
Photomicrograph of hot pressed copper-stabilized anion-deficient zirconia before firing. The darkest regions are pores, the very light regions are metallic copper inclusions.
